UNITED STATES
NUCLEAR REGULATORY COMMISSION
OFFICE OF NUCLEAR REACTOR REGULATION
WASHINGTON, D.C. 20555

February 5, 1988

NRC BULLETIN NO. 88-02: RAPIDLY PROPAGATING FATIGUE CRACKS IN STEAM
GENERATOR TUBES

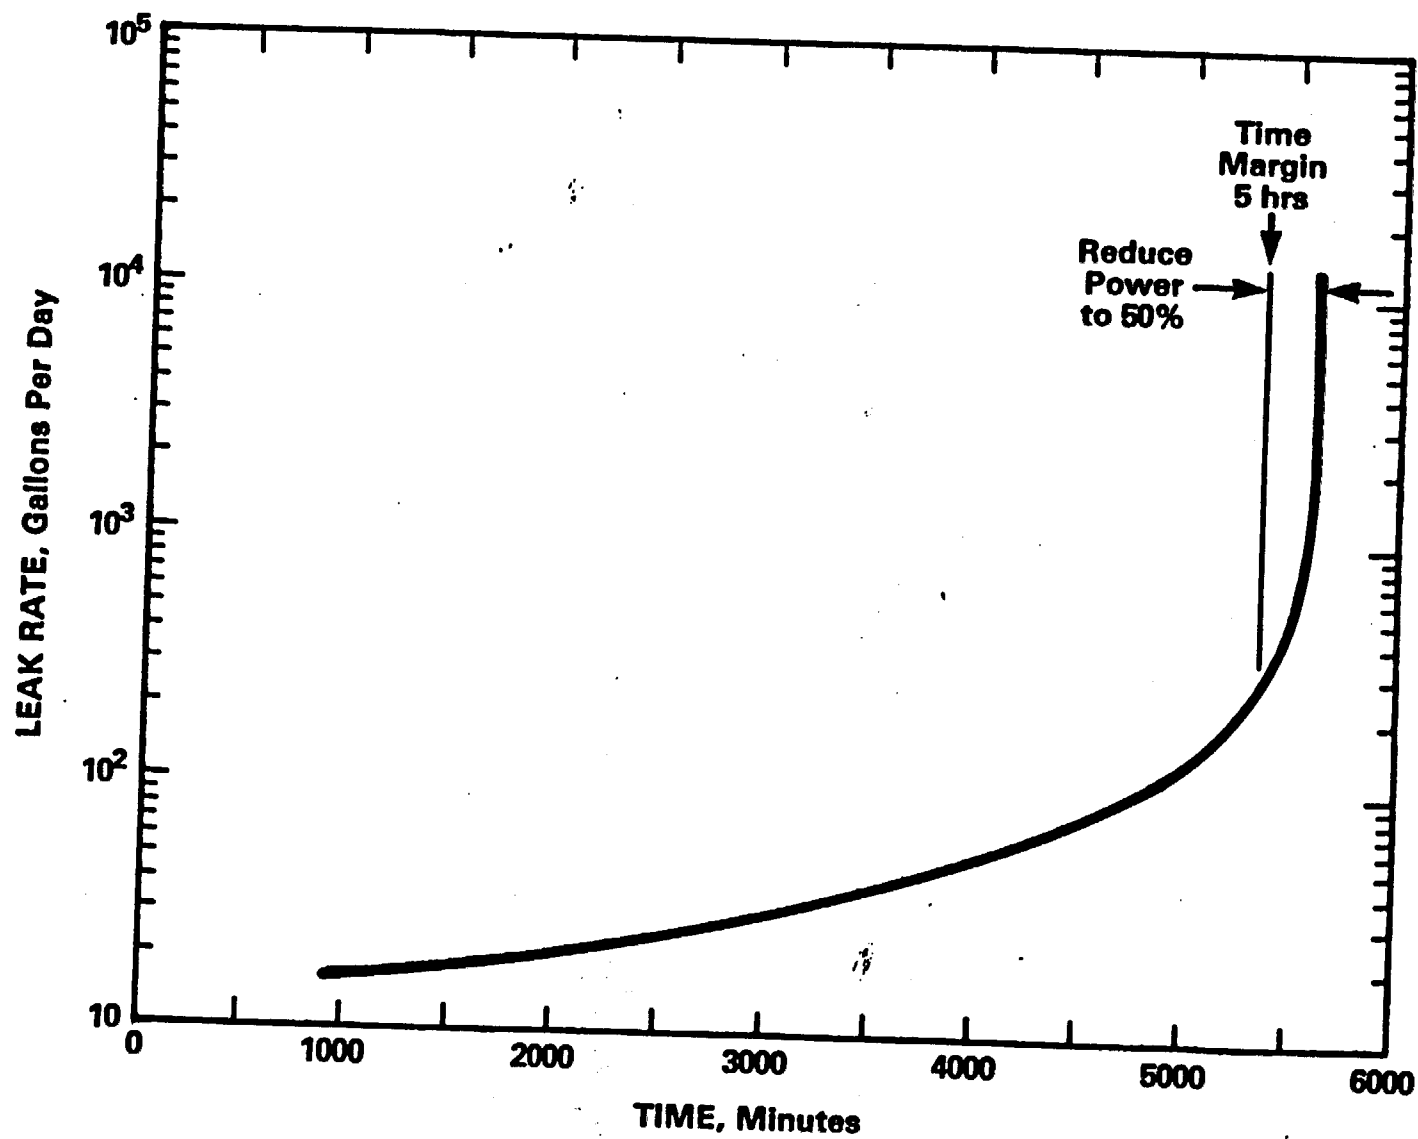
Figure 1 LEAK RATE VERSUS TIME,

- C. For plants where denting is found, the NRC staff requests that the following actions be taken:
 - 1. Pending completion of the NRC staff review and approval of the program described in C.2 below or completion of inspections specified in item A above to confirm that denting does not exist, an enhanced primary-to-secondary leak rate monitoring program should be implemented as an interim compensatory measure within 45 days of the date of receipt of this bulletin.* Implementation of this program shall be documented as part of the 45-day report. The enhanced monitoring program is intended to ensure that if a rapidly propagating fatigue crack occurs under flow-induced vibration, the plant power level would be reduced to 50% power or less at least 5 hours before a tube rupture was predicted to occur. The effectiveness of this program should be evaluated against the assumed time-dependent leakage curve given in Figure 1.

This program should consider and provide the necessary leakage measurement and trending methods, time intervals between measurements, alarms and alarm setpoints, intermediate actions based on leak rates or receipt of alarms, administrative limits for commencing plant shutdown, and time limitations for (1) reducing power to less than 50% and (2) shutting down to cold shutdown. Appropriate allowances for instrument errors should be considered. Finally, the program should make provision for out of service radiation monitors, including action statements and compensatory measures.
